# Test Certificate

**Item of Test** 1 pc(s), Bedplate - Repair

**Technical Data** intended for diesel engine Type SKL 6vD 26/20 AL2

## REPAIR REPORT

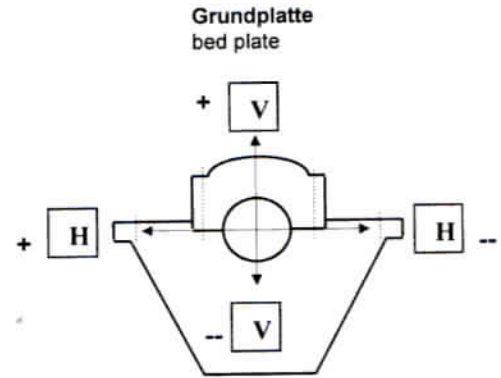
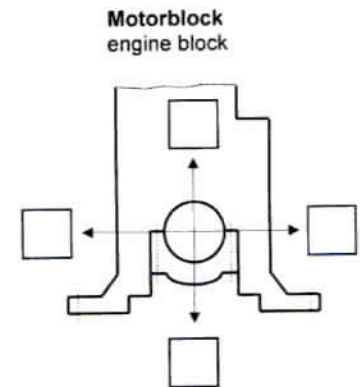
### Messprotokoll Easy Laser

Num	Ref	Dist	Ver	Hor
1	Ref	0	0.00	0.00
2		320	-0.01	-0.01
3		640	-0.01	-0.01
4		960	-0.02	-0.01
5		1280	-0.03	-0.01
6		1600	-0.01	0.00
7	Ref	1920	0.00	0.00
Max		0	0.00	0.00
Min		0	-0.03	-0.01
